# Evidence of Performance

Testing the joint characteristics of a sealing system between window and building structure in new condition and after a series of simulated short-time exposures

## Test Report

No. 16-003313-PR02

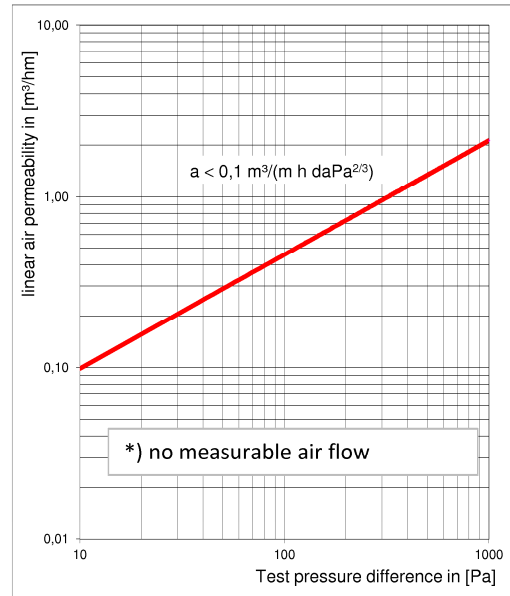
Graphics at negative wind pressure

**Result:** Q10= 0,00  
Q100= 0,00

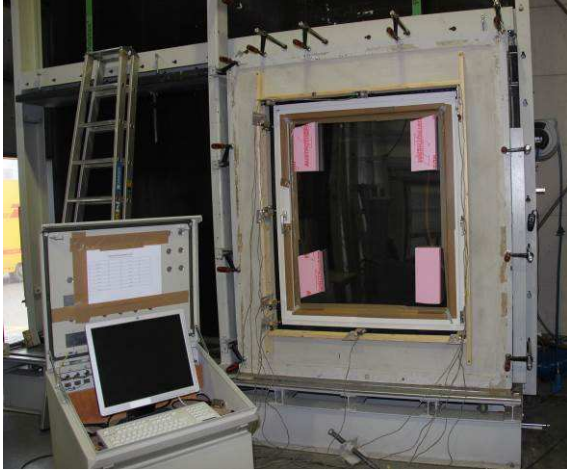
**Photo 1**  
Test specimen on test rig

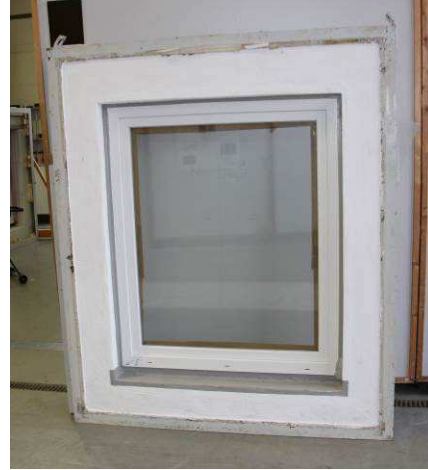
**Photo 2**  
Test specimen seen from outside

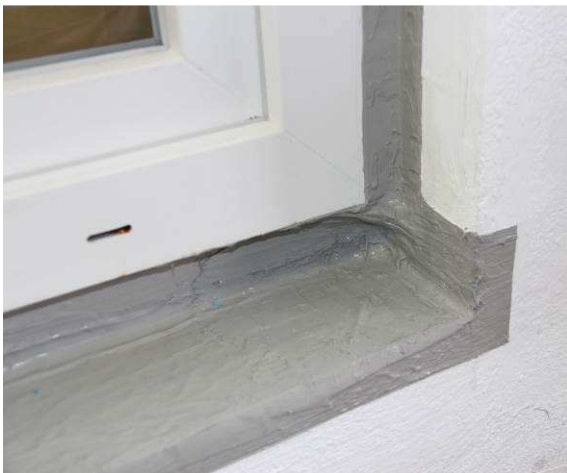
**Photo 3**  
Bottom corner details of external joint

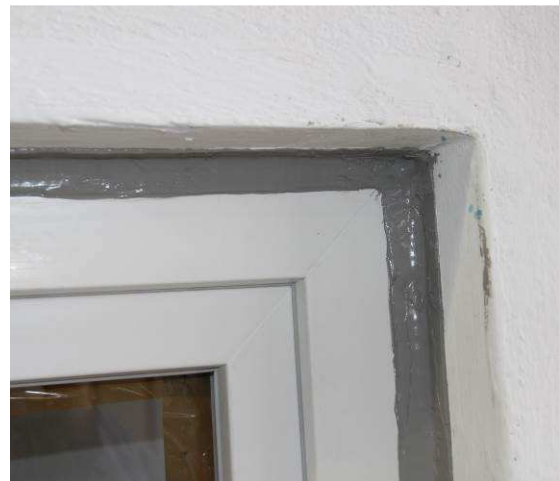
**Photo 4**  
Top corner details of external joint

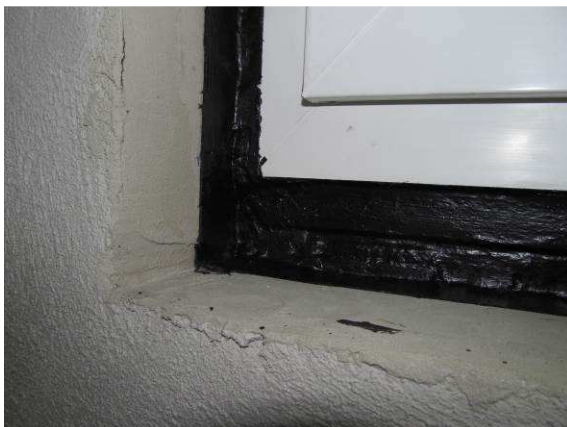
**Photo 5**  
Bottom corner details of internal joint

Material / Basis	synthetic dispersion
Installation	on sides approx. 10 mm applied to frame member / approx. 30 mm applied to reveal applied at bottom to window sill connecting profile, applied to parapet as well as approx. 30 mm over wall edge, see photo 3
Corner details	on four sides around perimeter
<b>Joint filling</b>	
Manufacturer / Date of manufacture	joints filled by the client on 10.11.2016
Designation / Type / Item No.	Soudal Flexifoam B2
Manufacturer	Soudal N. V.
Material	1-C-polyurethane foam (in-situ foam)
<b>Internal seal</b>	
Manufacturer / Date of manufacture	joints sealed by the client on 10.11.2016
Product name	sprayable and brushable joint sealing membrane Soudatight LQ/SP
Manufacturer	Soudal N. V.
Material / Basis	synthetic dispersion
Installation/application	on sides approx. 10 mm applied to frame member / approx. 30 mm applied to reveal applied at bottom to window sill connecting profile and approx. 30 mm to parapet, see photo 5

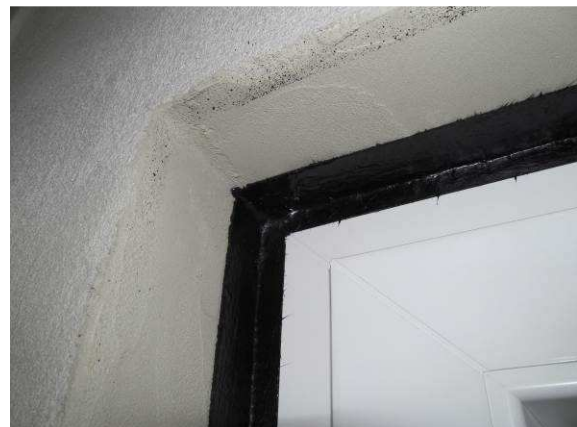
**Photo 6**  
Top corner details of internal joint
